## Root Causes for Failure of Electrical Submersible Pumping (ESP) Systems In West Kuwait

Khalid AL-Rasheedi & M. L. Chawla, Kuwait Oil Company

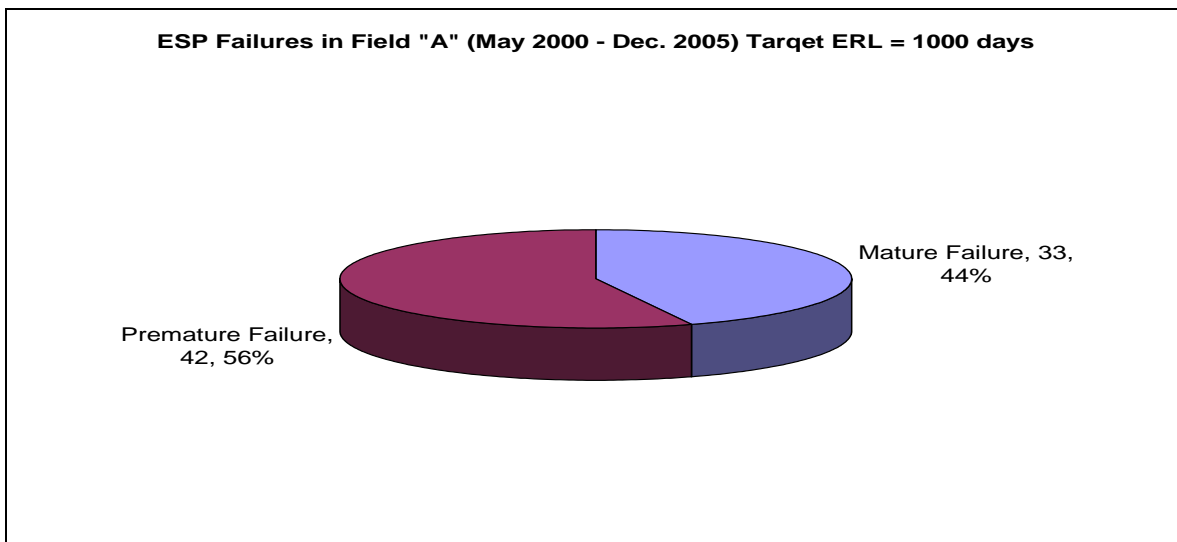
Plot – 3

During the period between May 2000 to Dec. 2005, 76 ESP failures were recorded in Field “A” in West Kuwait area. 75 units were pulled out and one unit was stuck in the well and declared as unrecoverable. 42 ESP failures out of the 75 failures were premature failures (less than 1,000 days run life). See plot – 3. The 42 ESP premature failures were studied and the root causes of the failure were classified – see plot - 4 - based on the following steps:

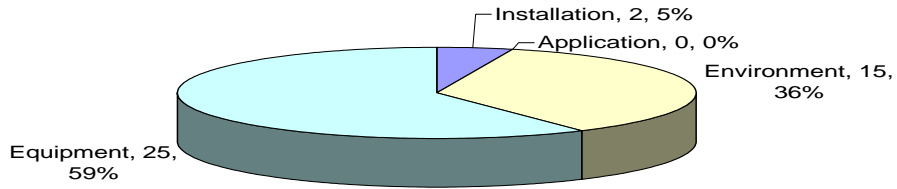
Plot - 4

3. Installation: This step looked into equipment handling at site, installation procedure, operation, monitoring, and trouble shooting as well as diagnostic ability of lease contractor’s personnel. 2 ESP failures were recorded in Field “A” due to operating against closed valve at the surface. See plot – 4.

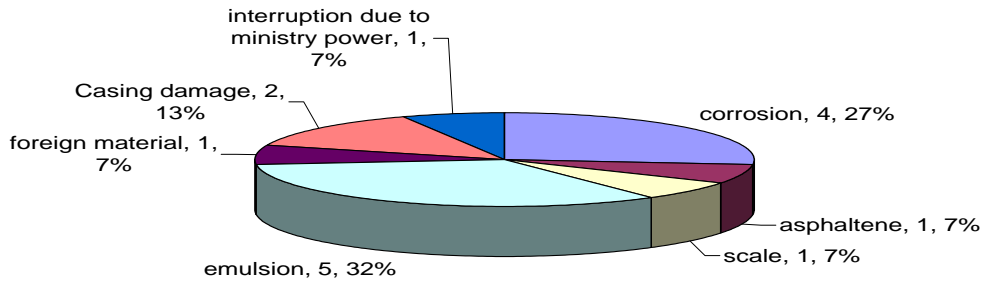
Plot - 5

2. Environment: This step involved review of actual well conditions and incoming power supply as against initial input. 15 ESP failures in Field “A” were due to harsh environmental reasons. Plot – 5 shows the details of the environmental related failures.

**Premature ESP Failures due to environmental reasons in Field "A" (May 2000 - Dec. 2005)**

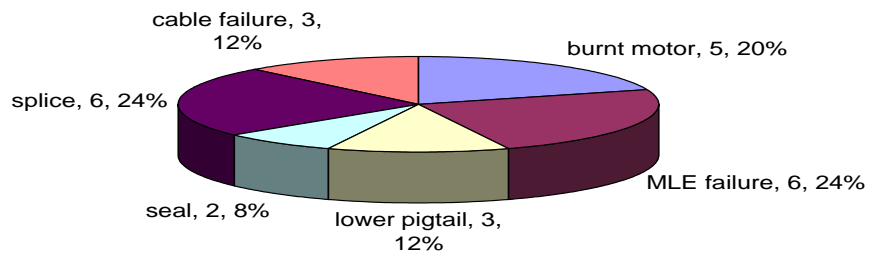
Plot - 6

4. ESP Equipment limitations: ESP failures took place due to ESP equipment related reasons in Field “A” were 25 failures where 72% of them were due to cable elements. Plot – 6 describes the ESP failures due to ESP equipment limitations.

**Premature Failure related to ESP equipment in Field - "A" (May 2000 - Dec. 2005)**

- Monel armored cable to be installed in wells where corrosion is known to be one of the failure modes. Also upgrading of down hole equipment specifications for using corrosion resistant down hole equipment is recommended.

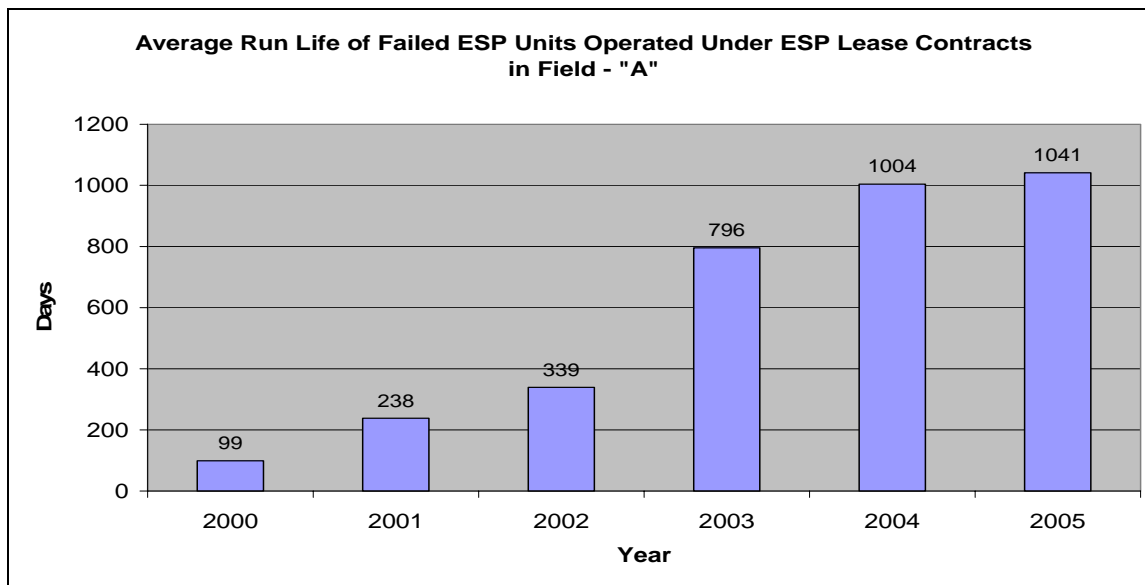
Plot - 2

During the life of the ESP lease contract, several ESP failures were dismantled and were studied. Certain corrective actions were taken based on the dismantling results to improve the subsequent ESP installation and to avoid another failure for similar reasons. This practice was productive and continuous improvement in the over all ESP run days (average ESP run life) was recorded. The average ESP run life in field – “A” for example improved from 99 days in year 2000 to 1,041 days in year 2005 (see plot -2).
